MOERAKI TOWNSHIP: INSTABILITY ASSESSMENT

A thesis
submitted in partial fulfilment
of the requirements for the Degree
of
Master of Science in Engineering Geology
in the
University of Canterbury

M.K. MOLINEAUX

1983

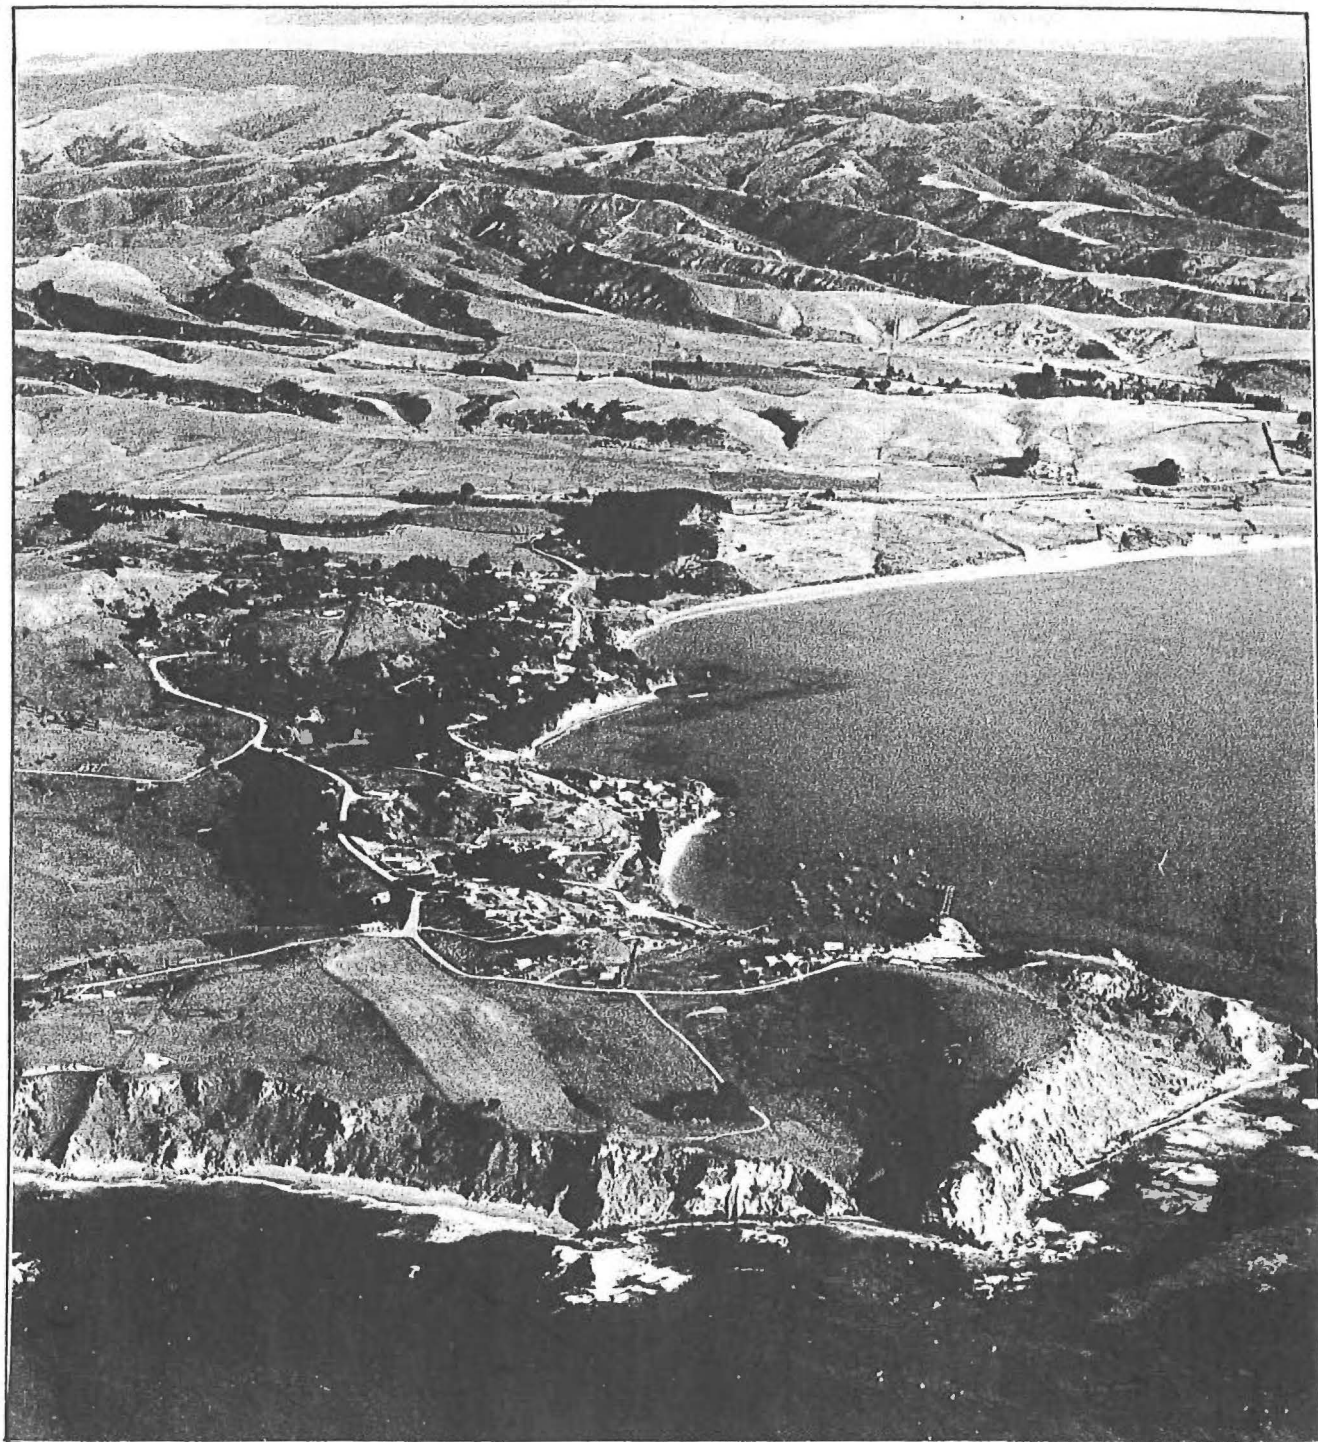
FRONTISPIECE

Moeraki township established along the northern coastline of Moeraki Peninsula, South Island, New Zealand. Salient varied relief in the township area is attributed to well delineated, deep-seated mass movement developed along the coastline. Oblique view looking inland west to the Southern Alps.

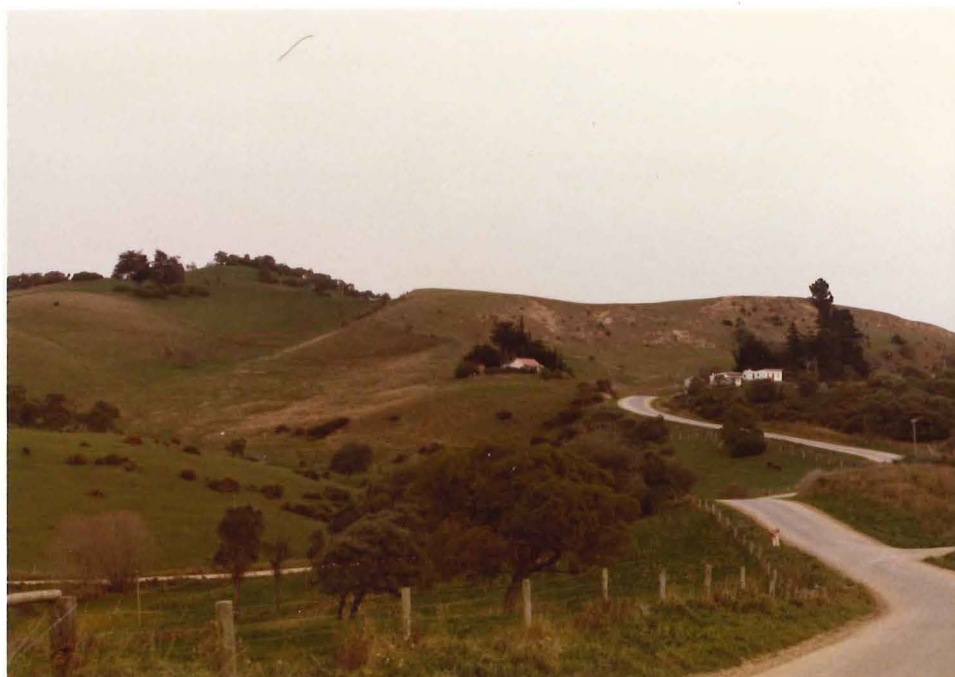
Fig.3.7: Principal escarpments of the Moeraki Slide; the degraded primary scarp delineating the first phase of instability and the secondary scarp, subsequent slope failure within the original slide mass. Note highlighting of the secondary escarpment by more recent shallow mass movement amassing talus colluvium. Looking southwest from 7350E,0100N.

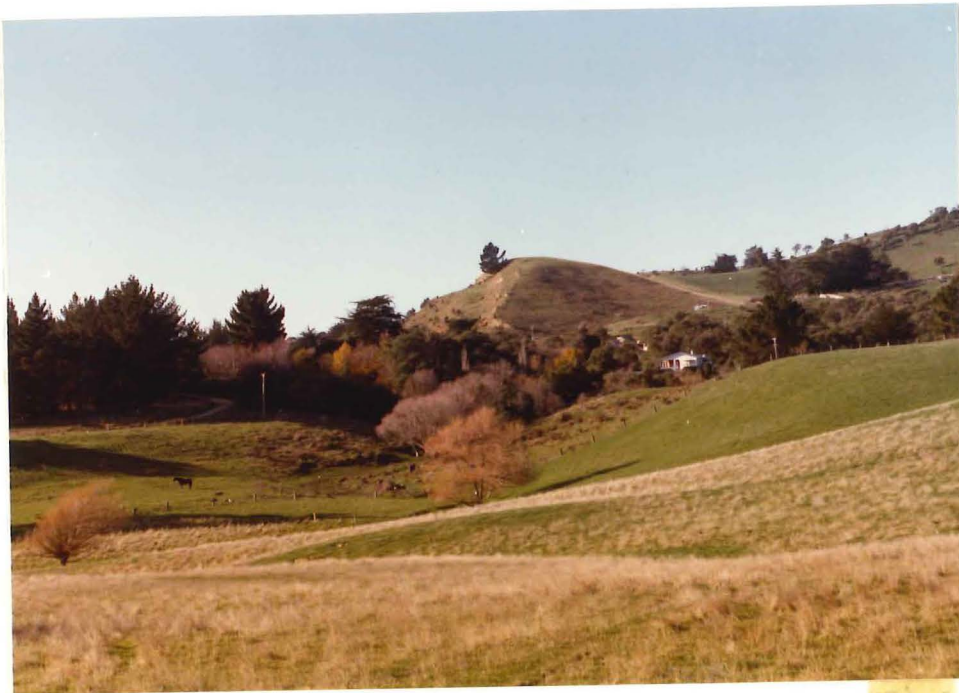
Fig.3.8: Primary and secondary escarpments of the Moeraki
Slide looking east from 6100E,0100N.

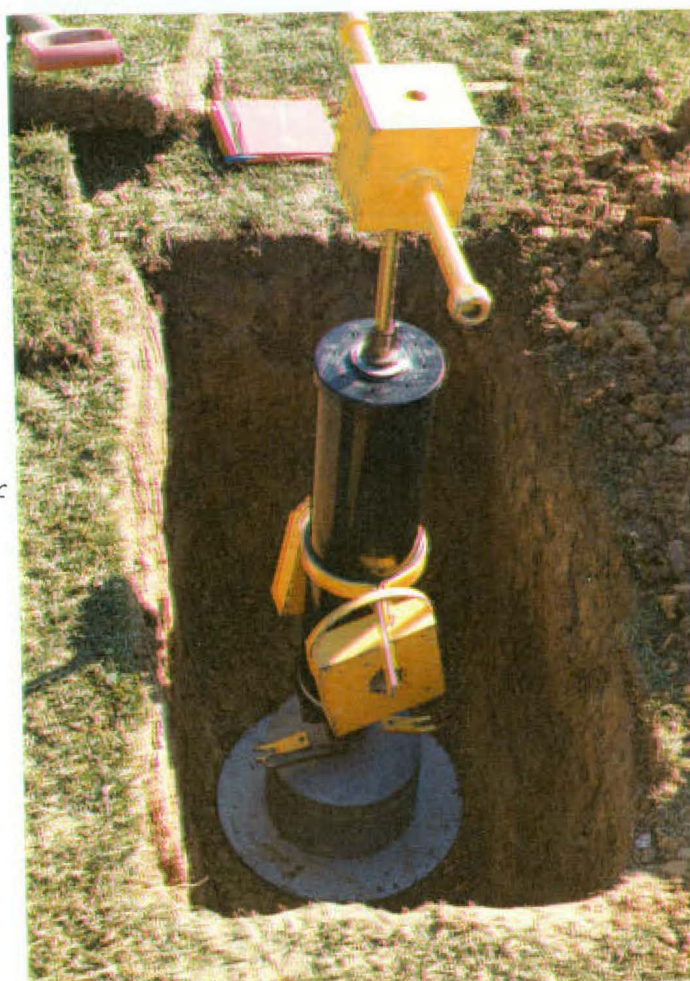
Fig.4.4(b): Balloon Densometer

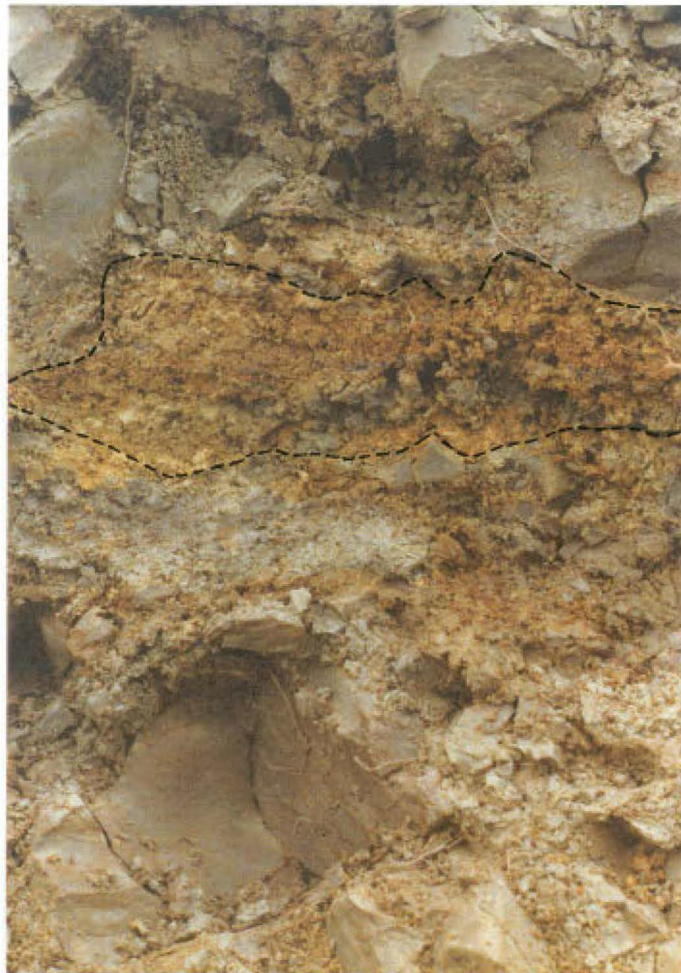
Fig.4.8: Weathered yellow-brown Kurinui mudstone exposed along the peninsula's north-western shore platform (6900E,0450N).

Hematite accounts for the yellowish brown colour of weathered Hampden and Kurinui Formations (Fig. 4.8).

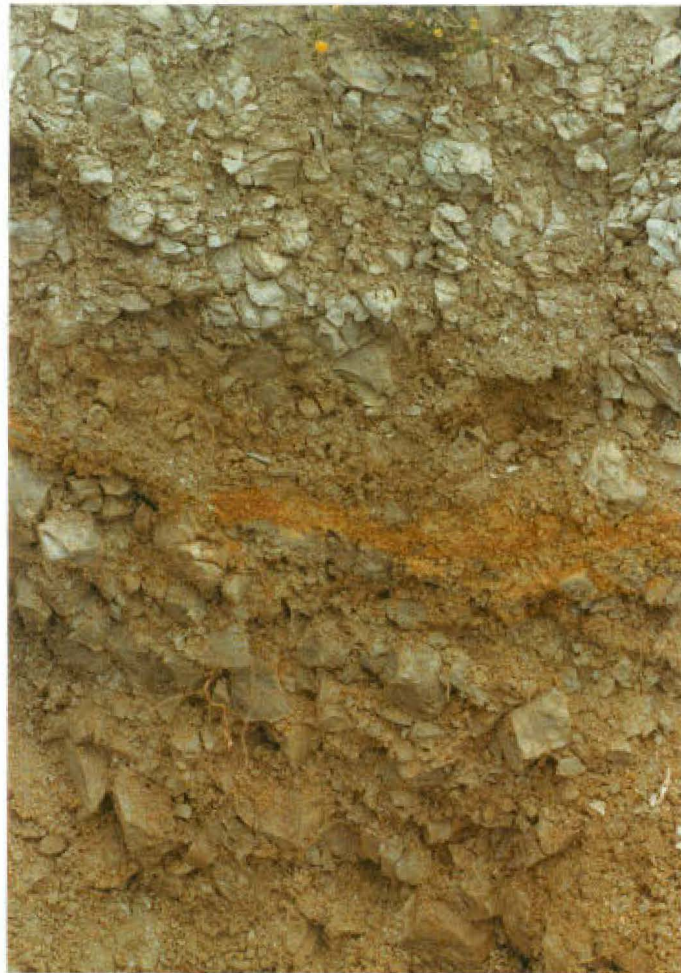
Fig.4.11: Oxidised relict joint dividing desiccated from moist in-situ mudstone. Accelerated slaking above the zone of saturation enhances development of yellow-brown regolith from blue-grey mudstone (7850E, 0550N).

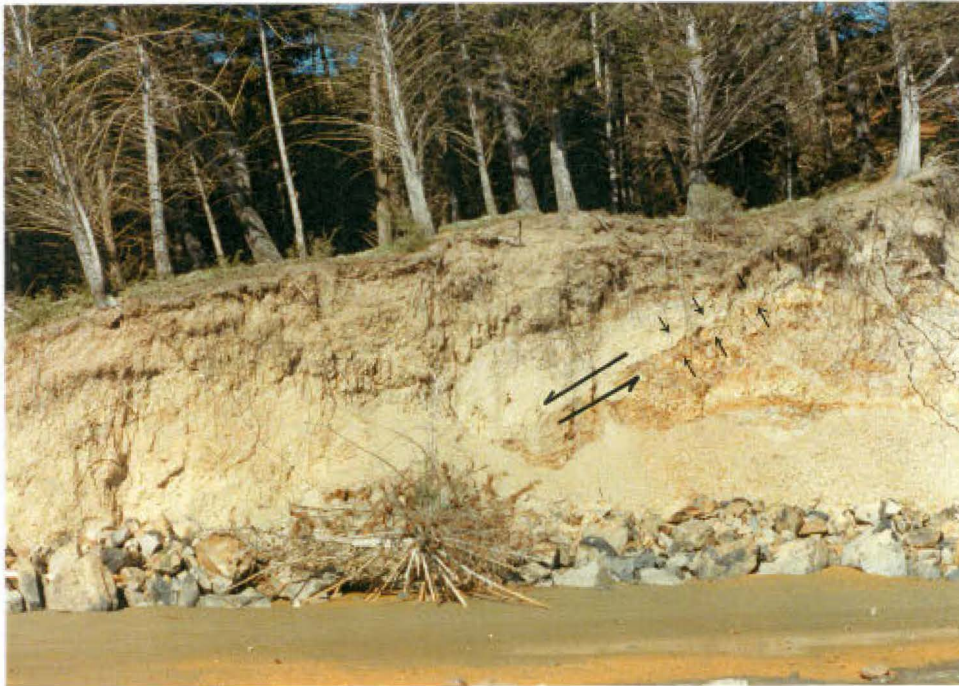
Fig.4.12: Well delineated sub-planar basal shear zone (arrowed) exposed along the northwestern shore platform. View looking south from 6900E,0450N.

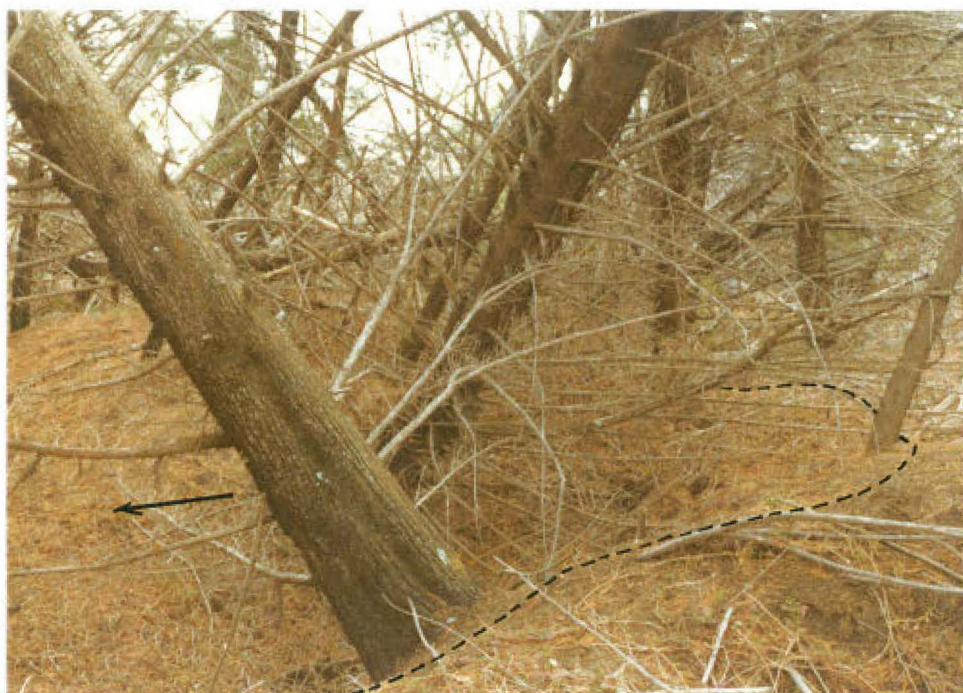
Fig.4.24: Wind blown trees accentuating development of a shallow debris slide. Looking north from 7000E,0350N.

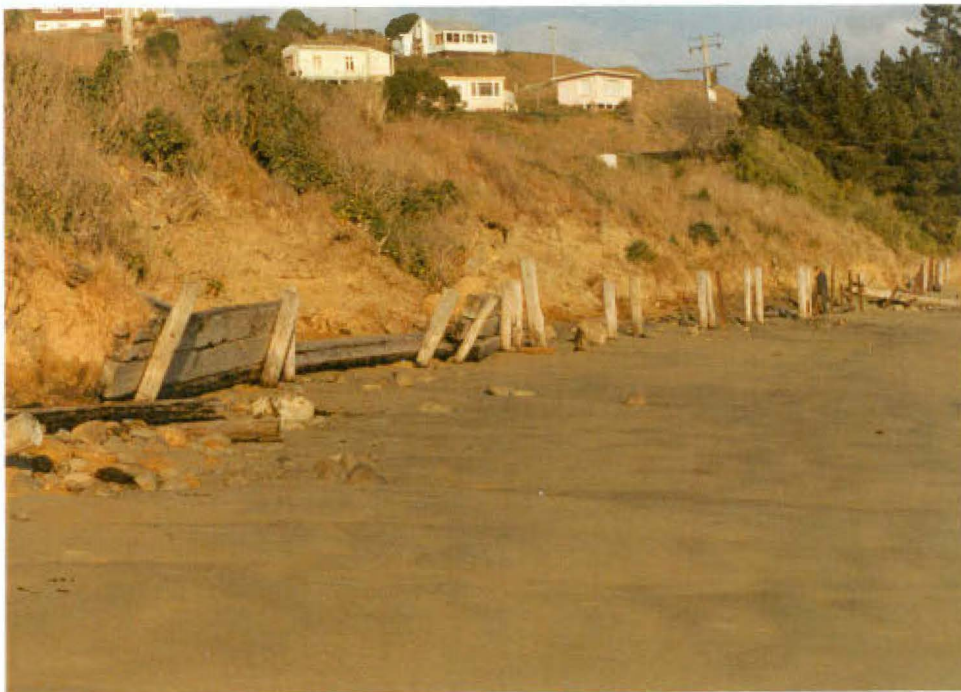
Fig.4.29: Remedial sea-walls have proven ineffectual in preventing retrogression of the peninsula's northern coastline to "equilibrium profile". Viewing west from 7700E,0500N.

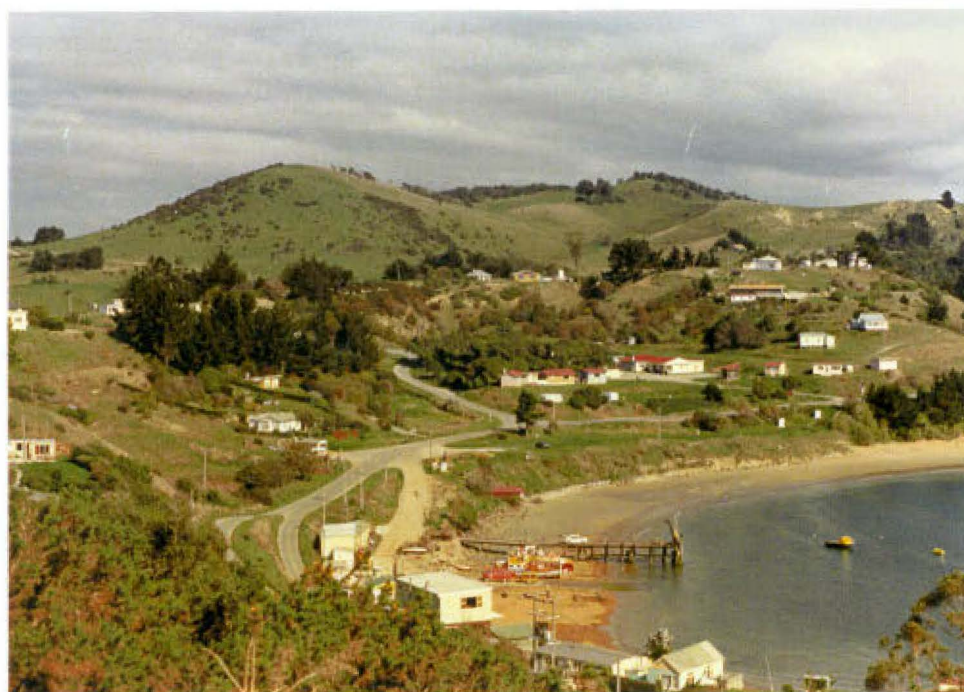
Fig. 5.1: Oblique view of the Motor Camp area principal escarpment and slide mass. Looking south from 7800E,0600N.

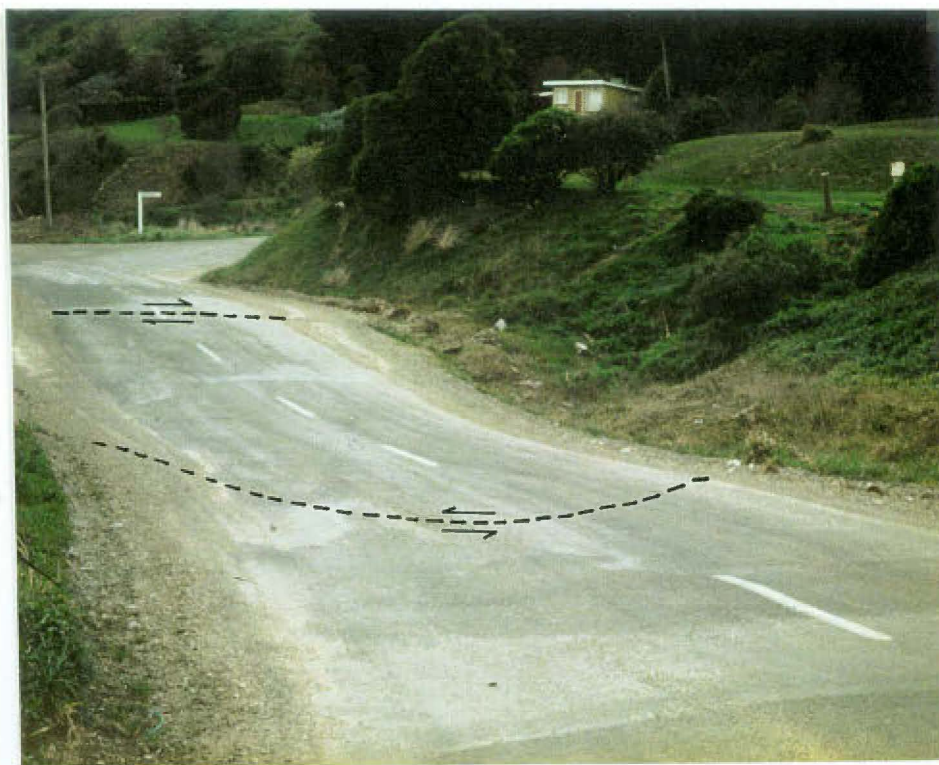
Fig.5.3: Haven Street, depicting significant and well defined (dashed) subsidence which poses a traffic hazard and requires annual repairs. Looking east from 7500E,0450N.

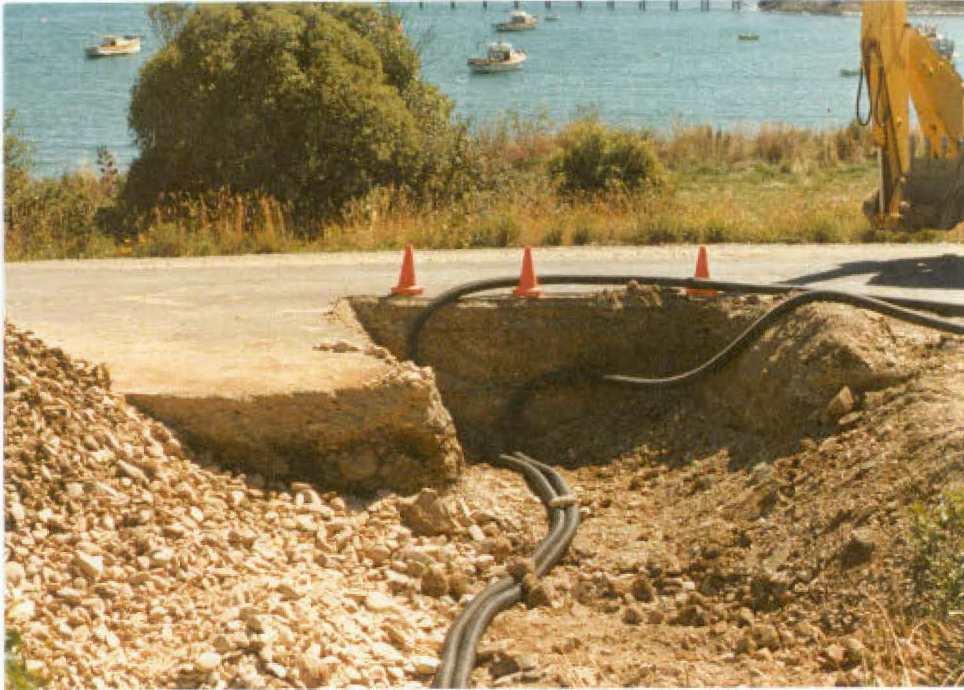
Fig.5.5(a): Culvert (PVC) amidst chaotic gravel-clay roading substrate; note previous subsided road levels. Viewing north from 7550E,0450N.

Drainage of excess water from all Motor Camp housing is concentrated behind Haven Street in the lower mid-section of the slide mass. Water is channelled into a slotted P.V.C. culvert which allows dissipation of drainage into roading substrate (Fig. 5.5). During summer months when Motor Camp accommodation is full, massive quantities of water are concentrated in this zone causing frequent ponding adjacent to the downhill slide of Haven Street.

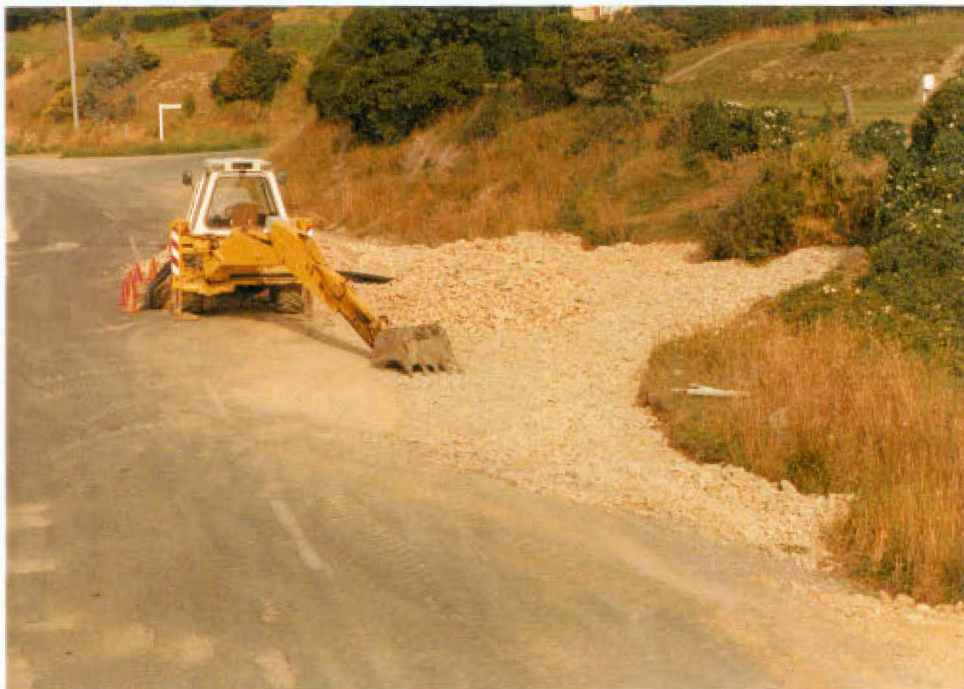
Fig.5.5(b): Portraying the extent of gravel "drain" channelling Motor Camp effluent into Haven Street culvert. Looking east from 7500E,0450N.

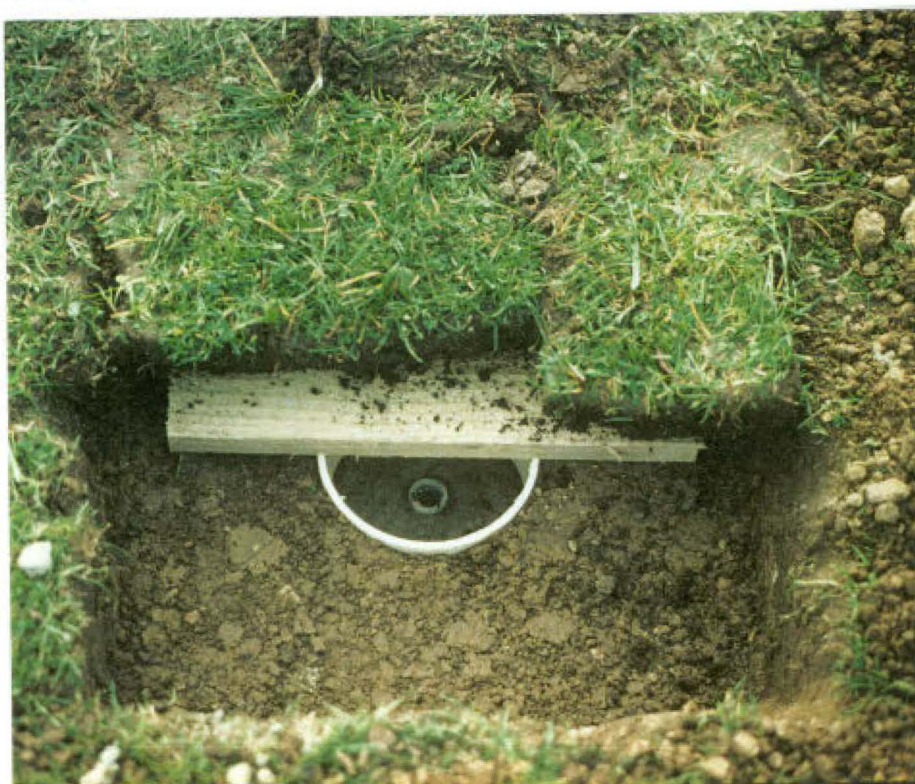
Fig.5.8: Concealed "base" point C, Motor Camp area survey network. (7550E, 0400N)

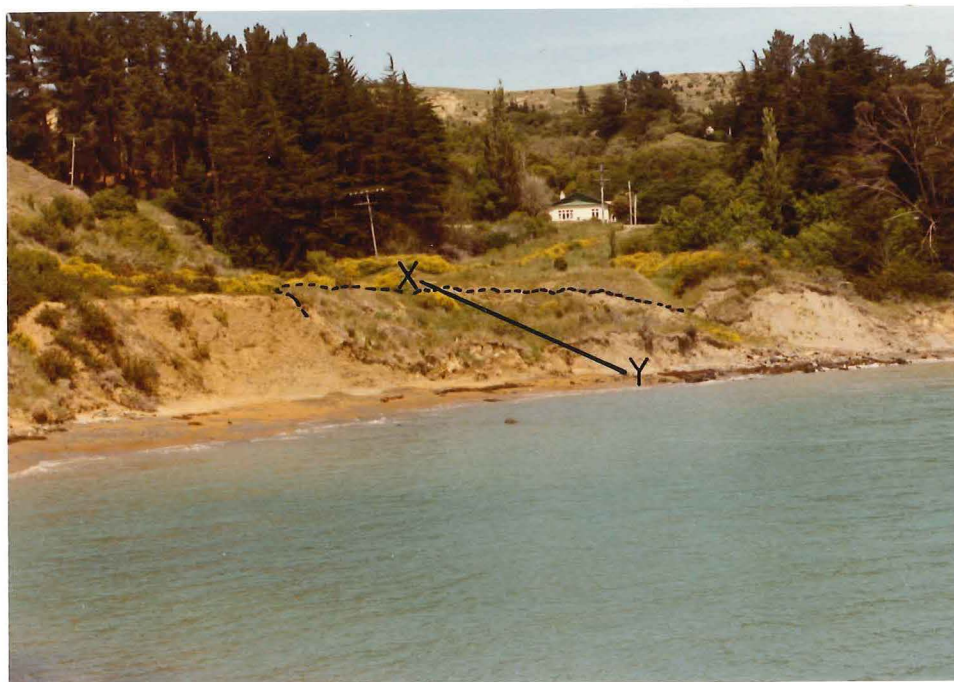
Fig.5.14: Oblique view, coastal debris flow-slide, well delineated by prominent escarpment (dashed); note well exposed basal shear plane facilitating accurate inference of subsurface failure geometry. Cross-sectioned denoted X-Y. Looking southwest from 7300E,0450N.

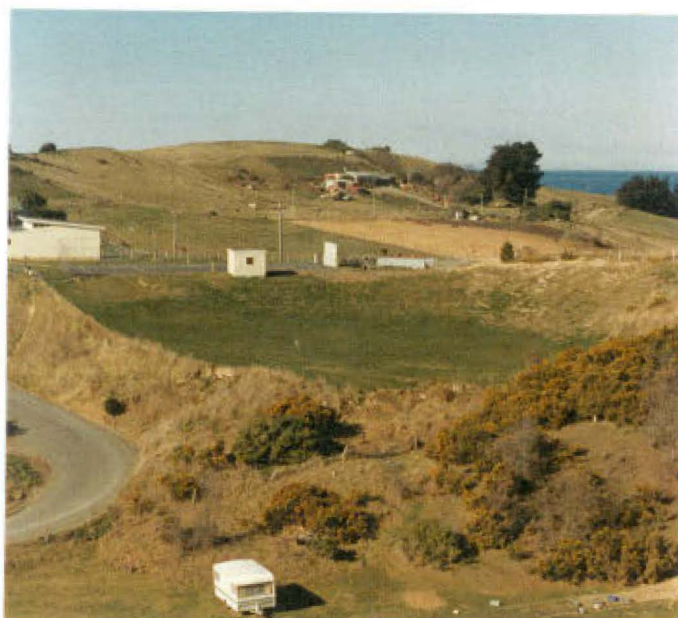
Fig. 5.18: School Slip delineating by salient escarpment actively retrogressing into the playground area. Surveyed profile marked X-Y. Viewing east from 7500E,0300N.

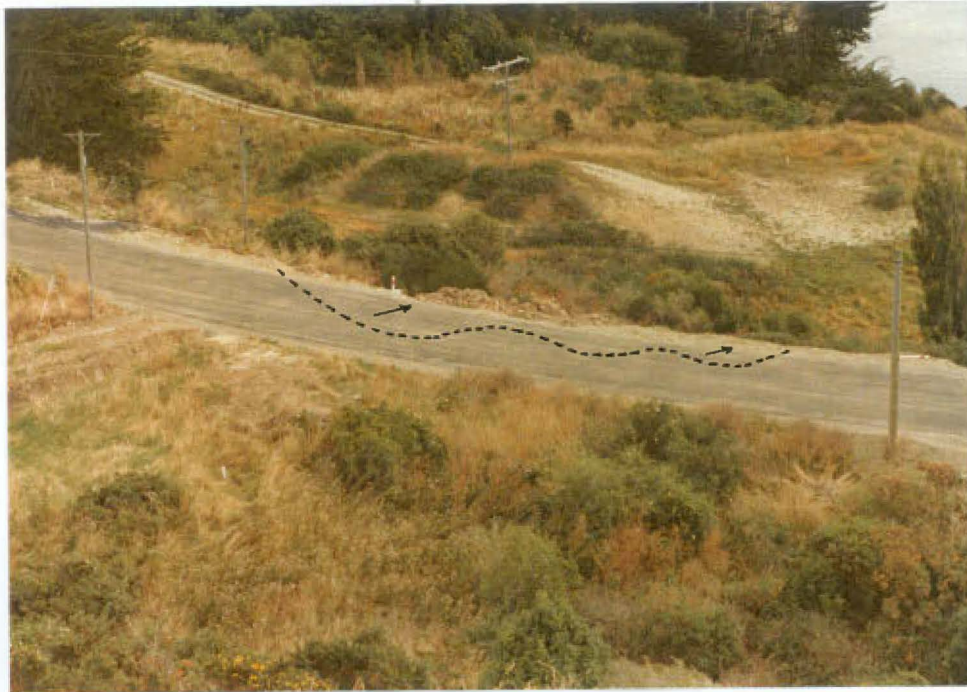
Fig.5.21: Haven Street, Davids Road area depicting zone effected by well delineated batter slope failure (dashed) prone to abrupt subsidence. Viewing northwest from 7300E,0250N.
